Technical Service Pointer

Technical Service Pointer #: W11690409
Action Required: Information Only
Release Date: July, 2023

Commercial Laundry

Top Load Washer Wire Color Change

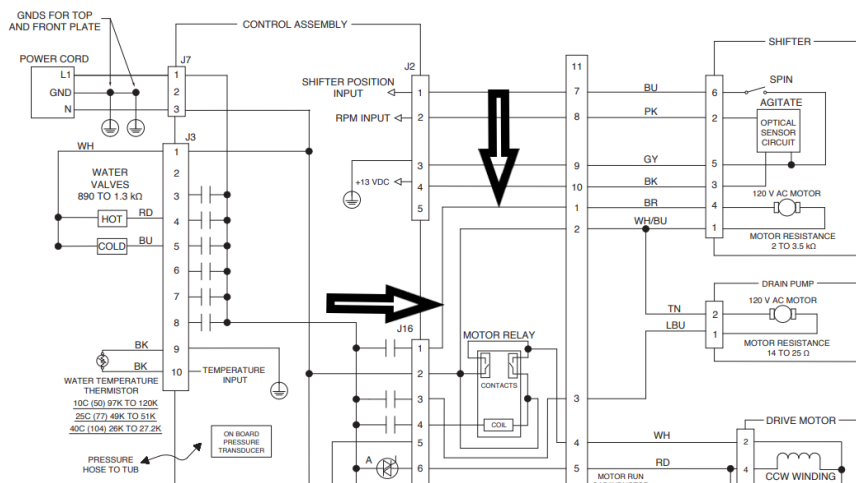
Wire color does not match schematic in upper main harness.

Due to a supply disruption there is a deviation in production to use a "Tan" color wire in place of a "Brown" wire. The wire is from Pin 1 of the J-16 connector on the CCU to the Pin 1 connection of the 12 pin Upper Main to Lower Main harness connector. See the portion of the wire diagram below with arrows pointing to the wire that is temporarily changing from Brown to Tan.
