# MAT20 OUTER BASKET PERFORATION

## THE QUESTION

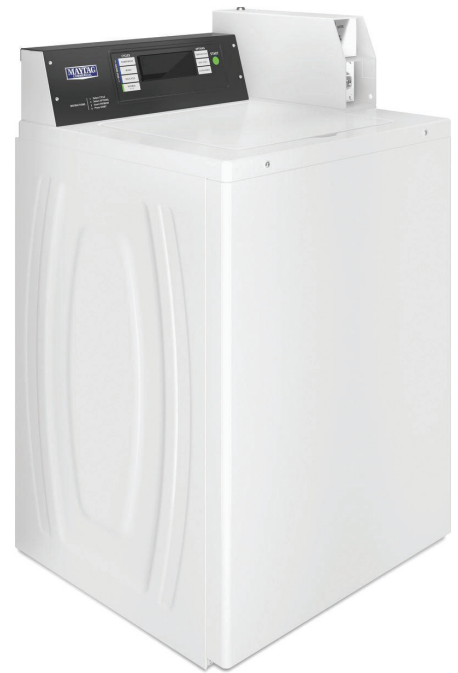
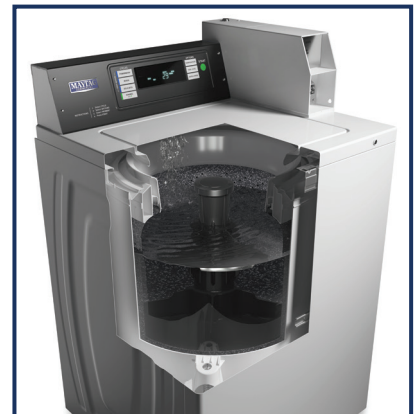
The MAT20 washer was engineered to prevent outer tub perforations by resisting debris from passing through to the tub. The smaller holes in the inner basket and a tub ring covering the gap in the baskets at the top of the machine help prevent debris from passing through and perforating the outer tub.
